## REROUTE THAT PVC SYSTEM

1985-1997 Ford Trucks, Broncos, and Vans with 5.0L and 5.8L engines.

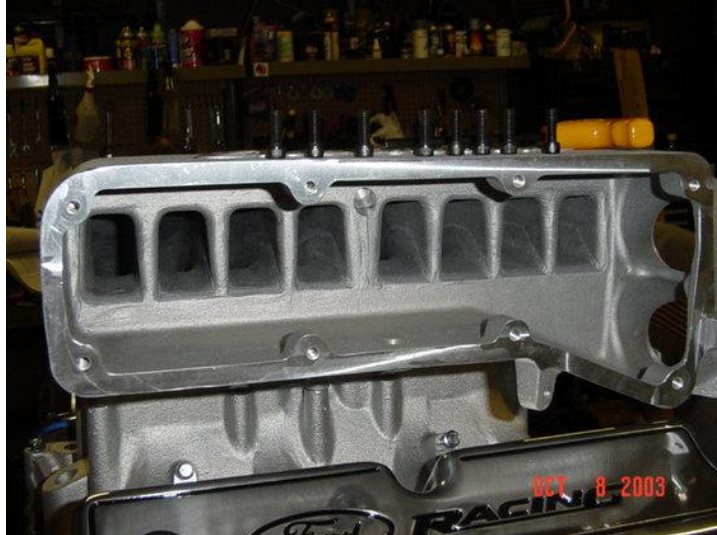
Failure of the rear piston, rod, or rod bearing (cylinders 5 & 8). After discussing the situation with several installers, the problem has been narrowed down to the PCV system. This picks up crankcase gasses from above the #8 cylinder and dumps into the back of the intake.

1. Plug the 3/8" (pipe) thread hole in the rear of the plenum where the PCV valve hose is connected.
2. Drill and tap a 3/8" pipe thread hole in the center of the plenum and thread the PCV connector into it.
3. Reconnect the PCV valve vacuum supply hose to the new location.
4. Be sure the drain hole in the baffle is open. The baffle is under the PCV location in the valve cover.
